Smoke and Dye Testing Summary

High Level Sewershed

Run Summary

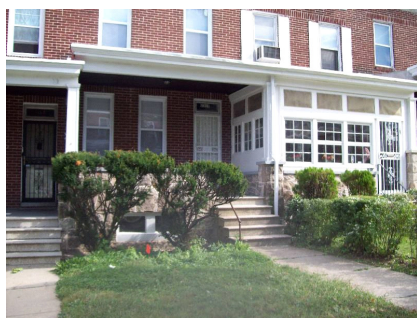
Picture \S1028-135-OB01-P01.jpg

Comments Smoke from cleanout in front yard. 2315 Longwood St.

Comments Front of house, 2315 Longwood St.
